Half-timbered kitchen “house”

by Polyhymnia camp

What it is: A walled structure with a canvas roof, in the style of a Tudor half-timbered house from the 15th-16th century.

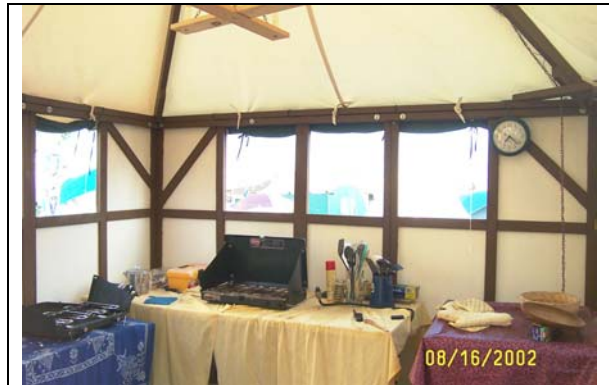
Figure 3 – Kitchen Interior from North

- The interior has a chandelier of electric candles (again, for fire safety reasons) and places to hang pots, equipment and cooking supplies like spices.

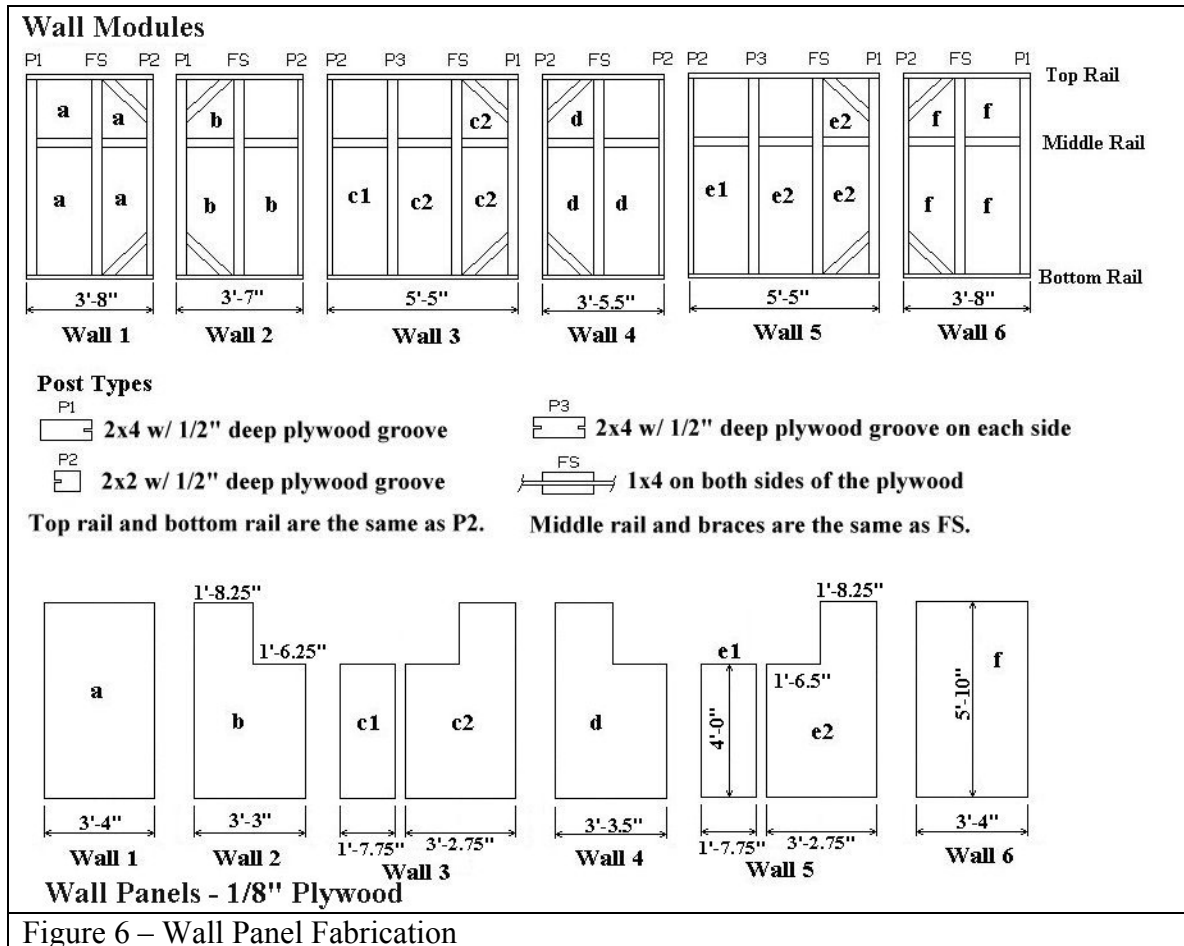
Figure 6 – Wall Panel Fabrication

Fabricating and Assembling the Wall Sections: The kitchen is constructed of 6 panels framed with 2x2, 2x4 and 1x4 whitewood stock (See Figure 6). The infill is made of 1/8” thick luan mahogany plywood. Nailing plates were used to attach the frame pieces to each other. Any

standard method of wood framing would have been appropriate for this modern structure. The period building would have been put together with mortise and tennon joints fastened with wooden pegs.

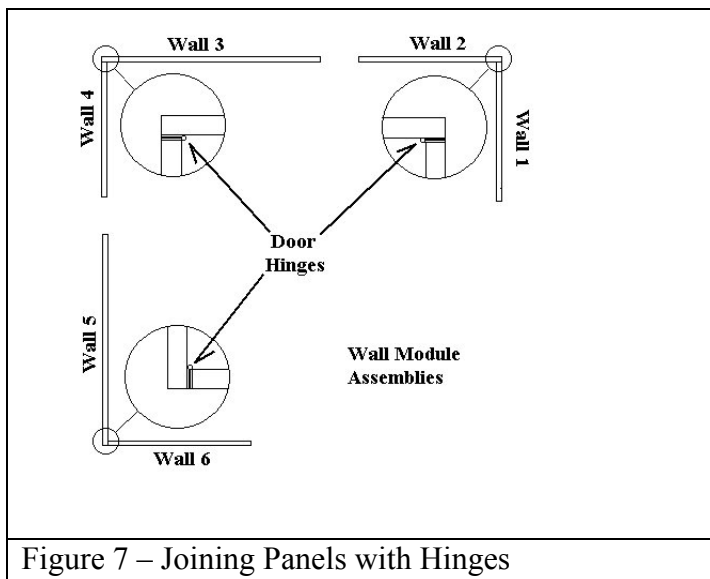
Pairs of panels were connected together using two standard door hinges for each pair of panels. (See Figure 7) The hinges were arranged such that the two walls would fold flat for storage.

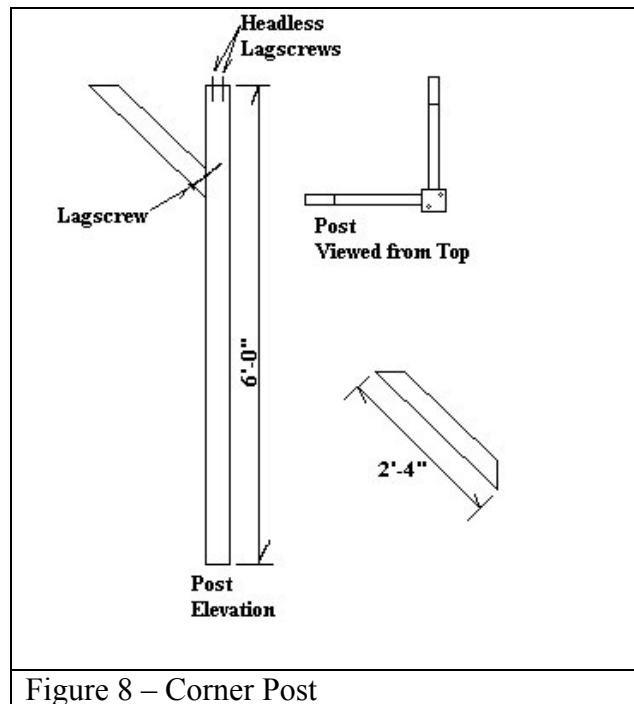
Figure 8 – Corner Post

Fabricating and Assembling the Corner Post: (Figure 8) Three corners of the roof of this structure are supported by the wall assemblies. The other corner is supported by a braced post. This post can be either a 4x4 or two 2x4s fastened together. The braces are cut from 2x4s and fastened into place with lag screws. For more strength, the braces could be mortised into the post.

Two headless lag screws were set into the top of the post with about 1.5" protruding to anchor the Rafter plates.

Step 5: The Corner Post was positioned under the remaining corner of the rafter plates. The headless lag screws in the top of the post socketed into holes in the bottom of the corner plates. The post braces were fastened into place with carriage bolts.
